TECHNICAL REPORT ARCCB-TR-99016

**GRAY LAYERS AND THE EROSION OF  
CHROMIUM PLATED GUN BORE SURFACES**

**PAUL J. COTE  
CHRISTOPHER RICKARD**

SEPTEMBER 1999

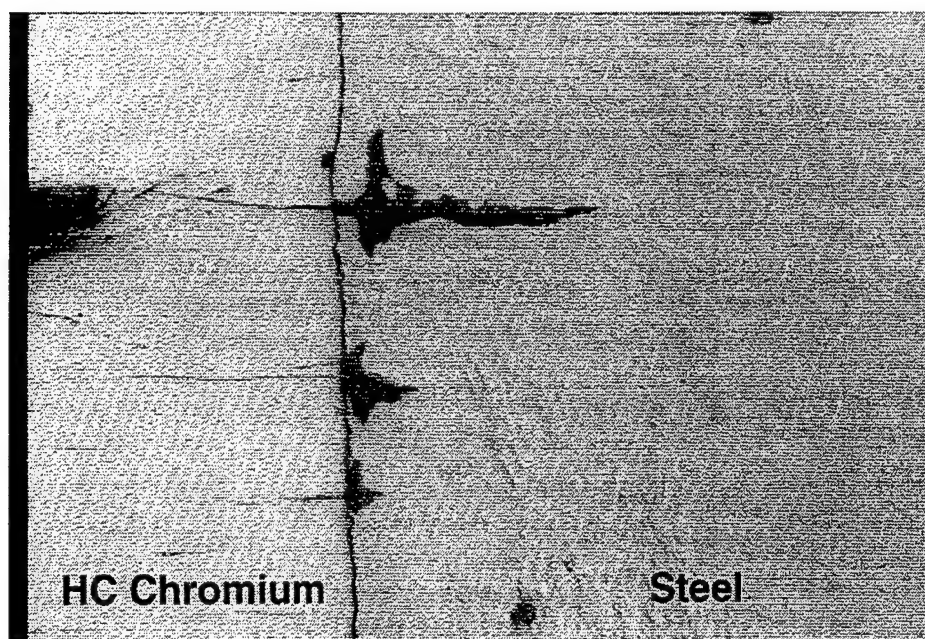
**Original 2000X**

Figure 1 is a photomicrograph showing erosion damage of specimen 1 at the chromium/steel interface after about 1200 conventional rounds. The dark areas at the tips of the chromium cracks are gas-steel reaction products. An unetched specimen was examined to more clearly delineate the reaction product, which appears as a solid gray material under optical microscopy. Metal attack clearly occurs via gas ingress through the fine cracks in the chromium plate. Energy dispersive spectroscopy indicates that the gray material is a mix of iron oxide and iron sulfide.

Figure 1. Micrograph of an unetched section of specimen 1 showing the chemical attack on steel. Note fissures are present within the steel reaction products.

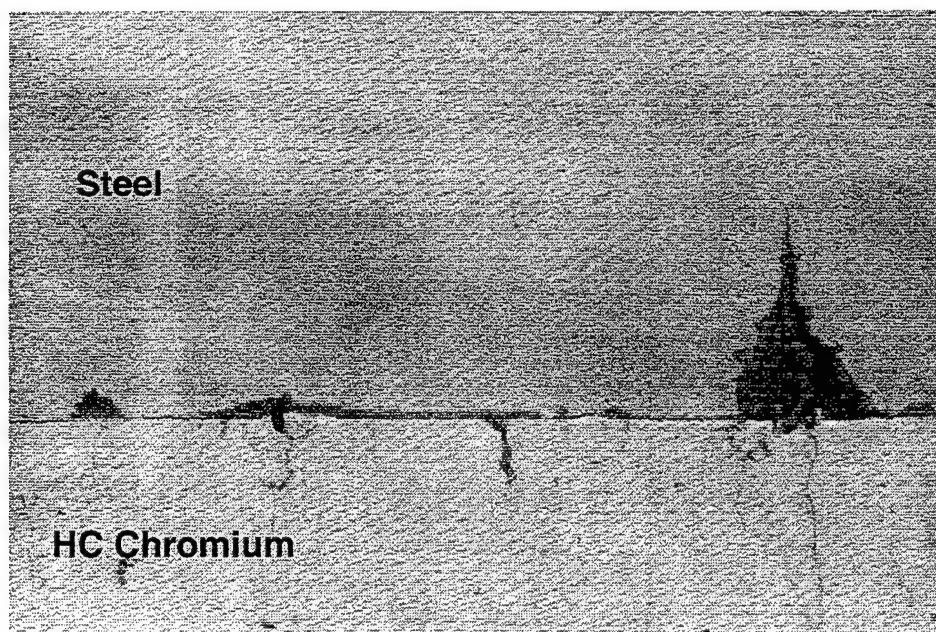
**Original 500X**

Figure 2 is an unetched micrograph from specimen 2 after approximately 80 high-temperature experimental rounds. The figure shows that the gas-steel reaction product can, in some instances, extend for large distances along the interface.

Figure 2. Micrograph of an unetched section of specimen 2 showing the chemical attack along the interface.

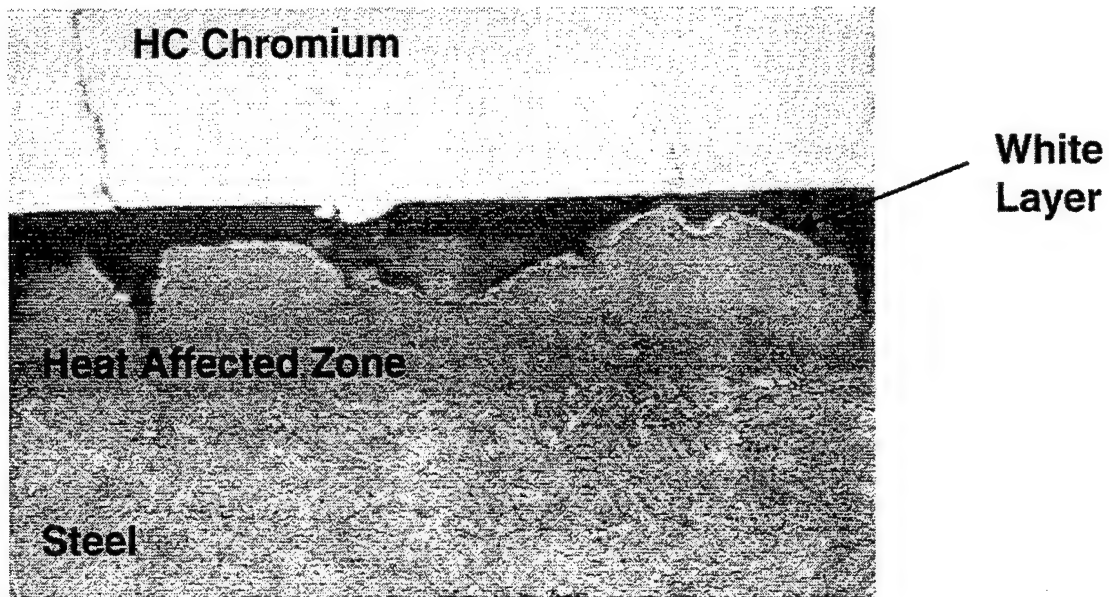
**Original 500X**

Figure 3 is a micrograph of an etched section from specimen 2. There is substantial removal of the gray material from the etching process (demonstrating that this is not a white layer), so that the pitting becomes more clearly defined. A heat-affected zone is seen in this micrograph. It can also be seen that a true white layer exists at the interface between the gray material and the steel. The white layer is only observable within heat-affected zones after etching. The gray material is partially removed by the etching process known as a Nital etch. The gray material is also removed by exposure to a drop of concentrated phosphoric acid, which leaves the surrounding steel and white layer unaffected. This ready attack by weak acid solutions is further evidence of a steel reaction product.

Figure 3. Micrograph of an etched section of specimen 2 showing dissolution of reaction products, heat-affected zone, and white layer.

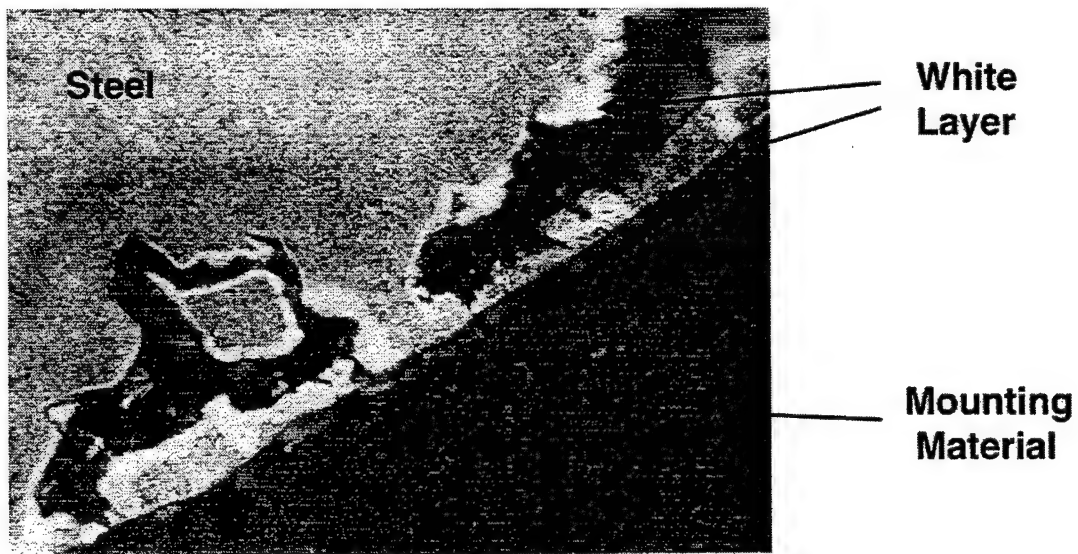
**Original 500X**

Figure 4 is a micrograph of a severely eroded area from specimen 2. There is a total chromium loss at this area, and the erosion process removed approximately a 5-mm layer of the steel at this location. A thin white layer can be seen at the steel surface, and extensive white layer formation occurs around the deep pits in the steel. This is known to represent fine-grained retained austenite stabilized by carbon and nitrogen with precipitates (primarily carbides) distributed throughout the retained austenite. The reaction products that form in the protected regions beneath the chromium a few millimeters away, as shown in Figure 3, are absent in this highly eroded area.

Figure 4. Micrograph of an etched section of specimen 2 where the chromium and an approximately 5-mm layer of steel beneath the chromium had been removed by erosion.

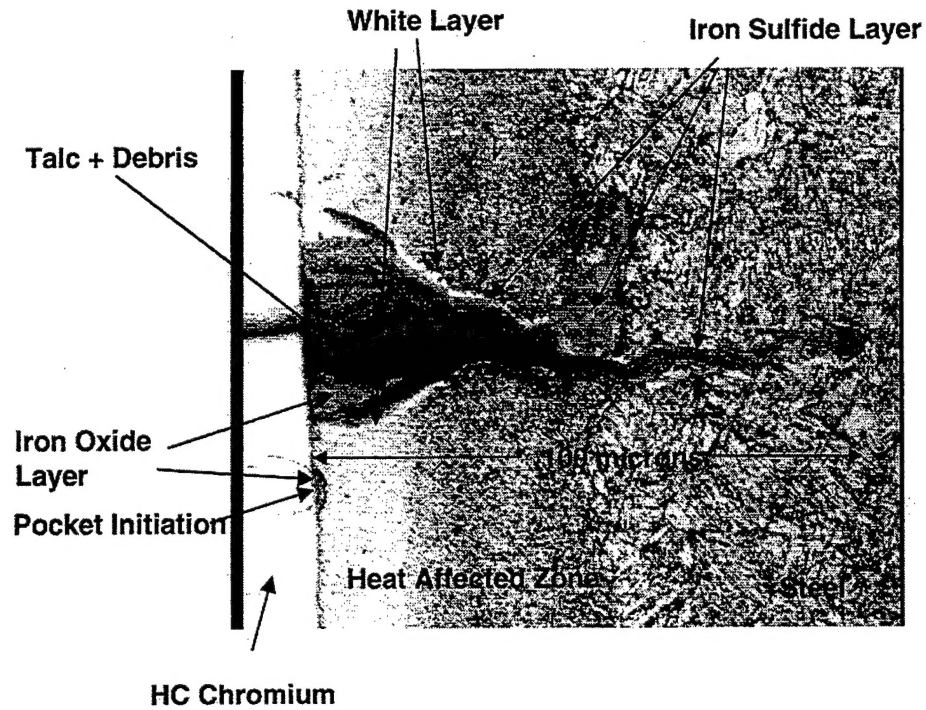
Figure 5 is a micrograph of an etched section from specimen 2 that was used for EDS chemical analysis. The chemical composition shows that the indicated compounds occur as part of the gray decomposition products. The white layer forms as a thin bright layer at the steel surface. It is known to be an austenite layer in the steel with carbide precipitates. Immediately adjacent to this white layer is an iron sulfide layer, which runs all along the pit surface and extends to the blunt tip of the pit, well beyond the heat-affected zone. The depth of the corrosion pit in the steel is approximately 100 microns. The reaction product covers the entire surface and thus forms at high temperatures during firing. At the core of the pit is a zone of iron oxide with

no evidence of sulfide. A mixture of talc and other debris is also seen in the core region in this case. Similar features are seen in all the other erosion pits on this specimen. Occasionally iron oxides and iron sulfides appear to be mixed together. The small pocket reaction zone at the tip of the fine chromium crack in Figure 5 shows the earliest stages of chemical attack. Only iron oxide is observed in this case. The initial progress of chemical attack radially into the gun tube appears to occur through fissures in the thick oxide or sulfide layers.

Figure 5. Micrograph of an etched section of specimen 2 indicating the chemical compositions deduced from EDS analysis.

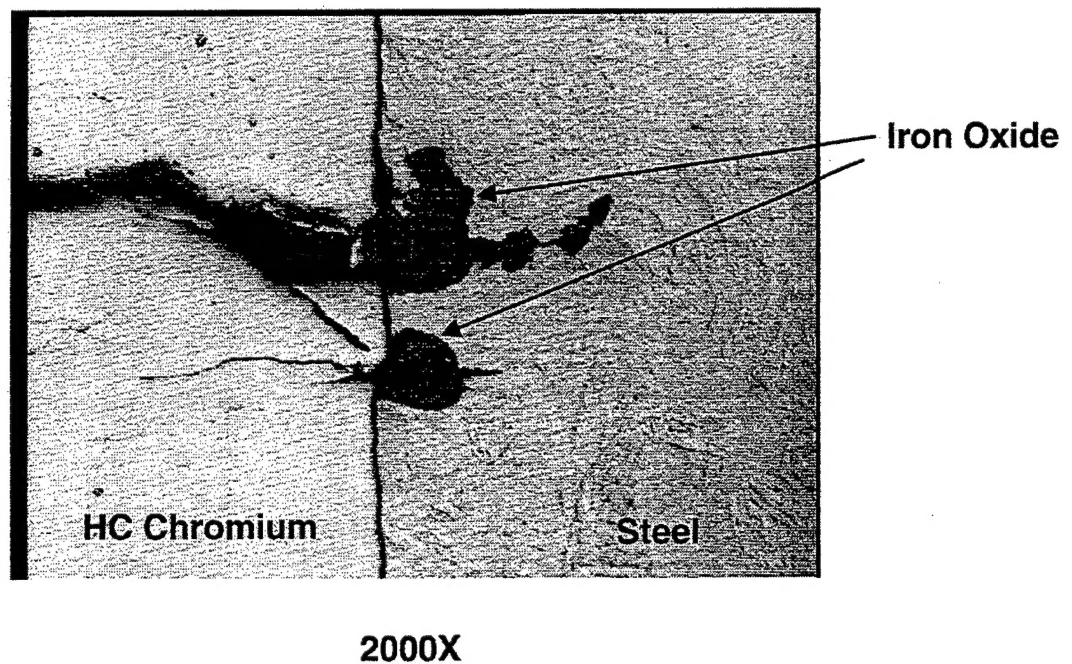
Figure 6 is a micrograph of an unetched section from specimen 3 (120-mm, 424 conventional rounds—approximately an equal mix of M829 and M829A2 rounds). Again the features are the same with gray reaction zones at the tips of the chromium microcracks. Energy dispersive spectroscopy shows the gray zones contain only iron oxide.

Figure 6. Micrograph of an unetched section of specimen 3 depicting different stages of chemical attack.

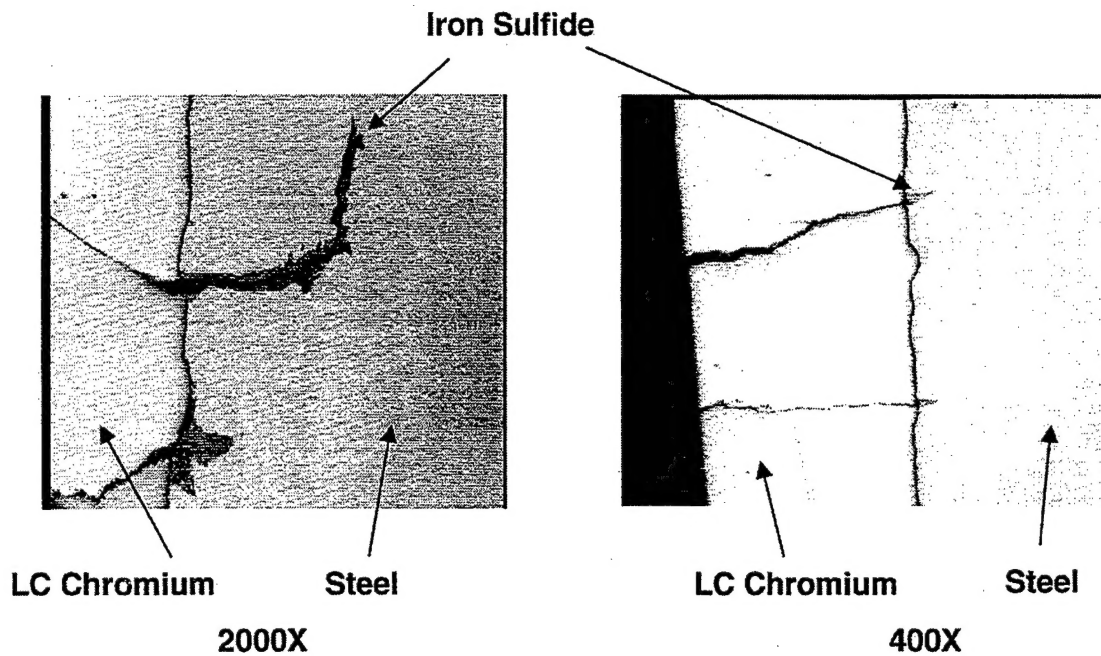
Figure 7 consists of micrographs of an unetched section from specimen 4 at 2000X and 400X. This section is from the LC plated 155-mm specimen. The numerous fine embedded cracks that occur between the major cracks with HC chromium are absent. In this case, the gray layers often exhibit a distinct yellow tint. Energy dispersive spectroscopy shows only iron and sulfur, indicating that the gray/yellow reaction zones are sulfides. The sulfur likely originates from the potassium and/or sodium sulfate used as a flame suppressant in the 155-mm.

Figure 7. Micrographs of specimen 4 at 2000X and 400X showing initiation and propagation of chemical attack.

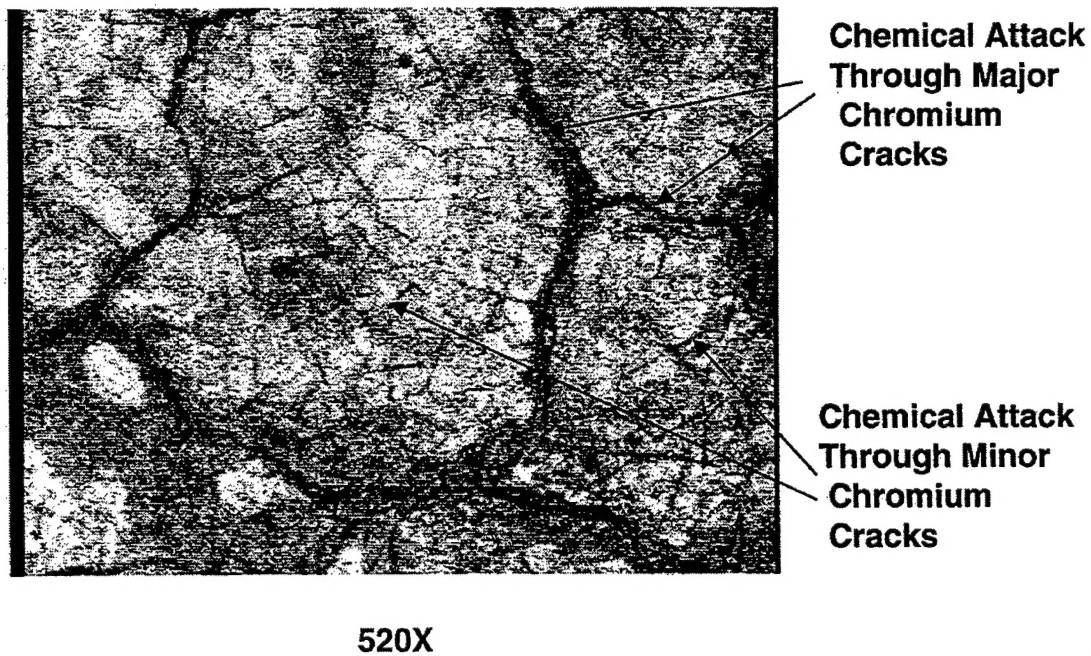
Figure 8 is a micrograph of the bore surface from specimen 2 where all of the chromium coating has been electrochemically stripped away from the steel substrate. It is seen that the entire array of large and small cracks that are present in the chromium are replicated in the erosion pattern in the steel. From this specimen orientation, all of the major fracture-like features in the steel are also solidly filled with the same dark glaze-like material (along with many of the fine crack-like features). This supports the observations regarding crack filling described above. From the previous analysis of the same tube, the dark fill material is known to be predominantly talc.

The original chromium layer in Figure 8 was heavily spalled prior to stripping this specimen. The nature of the spalling is a removal of numerous individual islands of chromium whose boundary is determined by the major chromium cracks. In the initial stages of spallation, the chromium has the appearance of being heavily pitted with many small pits visible without magnification. After stripping away the chromium, there is no evidence of pitting or spallation extending into the steel substrate; thus, the spallation of the chromium does not originate by fracture of the steel. This is in accordance with LCSM inspection of dozens of spalled regions, which show the depth of the spalls extending no deeper than the chromium/steel interface zone. Usually, in both the LC and HC specimens, fragments of chromium are observed adhering to the steel at the flat bottom of the spalled regions showing that the spallation originated from metal failure in the chromium or at the chromium/steel interface region.

Figure 8 also shows that the erosion of the steel occurs as closed paths around rounded chromium islands. These paths extend into the steel as chemical attack drives the "heat-checking" process through the chromium cracks and into the steel. It has been observed that the depth of penetration of damage can be orientation-dependent (ref 5).

Figure 8. Micrograph of specimen 2 steel/chromium interface plane after electrochemical removal of all chromium in this area. Note the depth of penetration of the corrosion zones into the steel should vary roughly with the widths of the corrosion gaps at the surface.
